THE LAST WILL AND TESTAMENT OF THE BGA VOID

David Hillman, Dave Adams, Tim Pearson, Brad Williams, Brittany Petrick, and Ross Wilcoxon
 Rockwell Collins
 Cedar Rapids, IA, USA
 ddhillma@rockwellcollins.com

David Bernard, Ph.D., John Travis, Evstatin Krastev, Ph.D., and Vineeth Bastin
 Nordson DAGE
 Fremont, CA, USA
 david.bernard@nordsondage.com

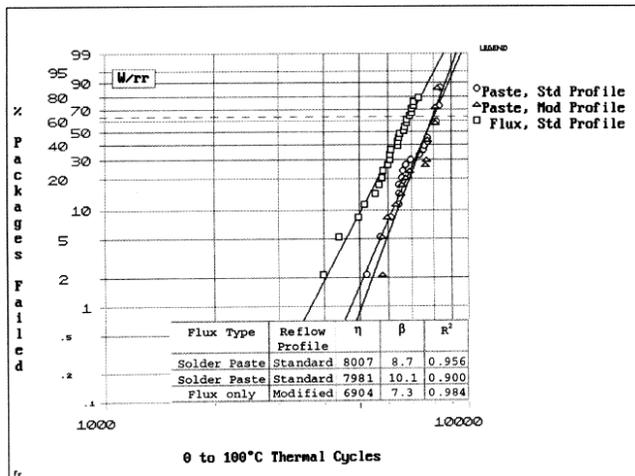
Figure 2. Failure Data Weibull Plot from Banks [5]

Figure 2 illustrates Weibull plots that show that BGAs with voids (i.e. Mod Profile) and BGAs without voids (i.e. Standard Profile) did not have distinguishable solder joint failure populations. Banks' work was one of the earliest published tin/lead solder alloy investigations to demonstrate that macro voids did not interact with the solder joint failure cracks and their presence did not cause solder joint failure.

- Voids had no effect on solder joint integrity (Figure 2)

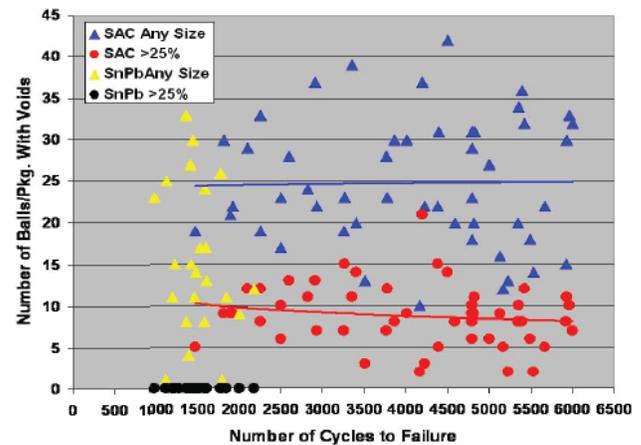
Figure 3. Solder Joint Voiding Versus Cycles to Failure for CSP84 Component [6]

The SPVC investigation demonstrated that the number of cycles to failure did not correlate with void size. If there was a negative influence of voids the solder joint integrity, Figure 3 would show a cluster of early low cycle failures for larger voids and a cluster of late cycle failures for the small voids. This was not the case; the results show a uniform data spread for the number of cycles to failure for both void size populations, with no distinctly different groups for either the tin/lead or lead-free solder alloys.

- Both test vehicles had voiding greater than 25% of the X-ray image area in multiple components
- SAC solder had more voids than SnPb solder
- No correlation was found between void size and solder joint integrity (Figure 3)

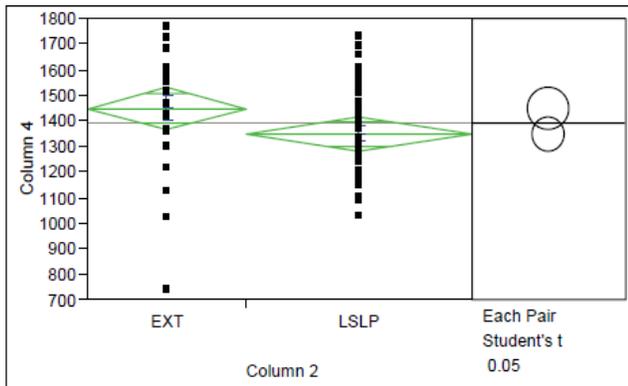
Figure 4. Statistical T-Test for Solder Joint Voiding Showing Indistinguishable Failure Populations [7]

Kim’s investigation utilized two different reflow profiles – typical (aka LSLP) and non-typical (aka Extreme) – to generate voids in the BGA solder joints. The LSLP reflow profile produced minimal voiding whereas the Extreme reflow profile resulted in voiding as large as 60% of the solderball diameter. Preconditioning of the BGAs prior to reflow (10 days of 60°C/60%RH) was included in the test as an additional technique for generating voids. Analysis of the thermal cycle results revealed that there was no statistically significant difference between the void and void-less solder joint populations for the 144 I/O BGA components (Figure 4).

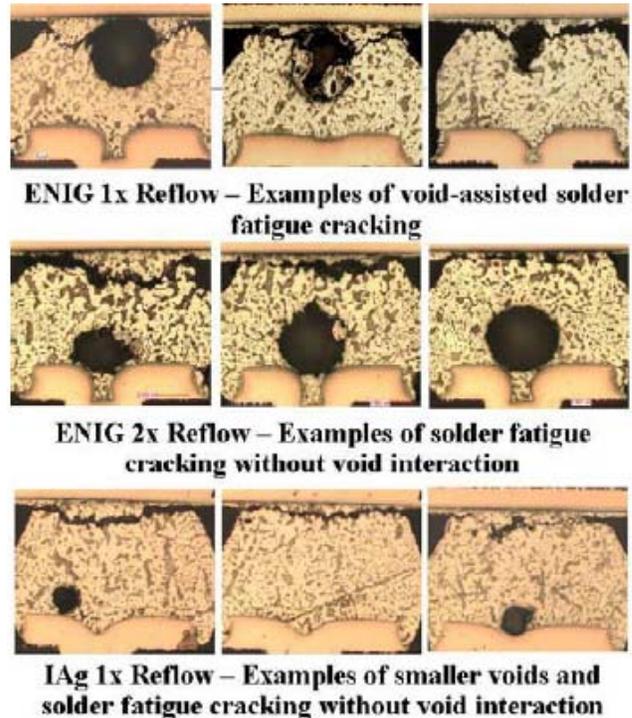
Figure 5. Solder Joint Void Versus Crack Path Interaction, S. Sethuraman et al [8]

The Sethuraman investigation demonstrated that the solder void location, rather than the solder void size, is the primary mechanism by which voids can reduce solder joint integrity. Only voids in the solder joint crack propagation path reduced the solder joint thermal cycle life.

- Void size alone was insufficient to define acceptance for solder joint reliability
- Solder voiding only reduced the reliability when the voids were located in the crack path (Figure 5)

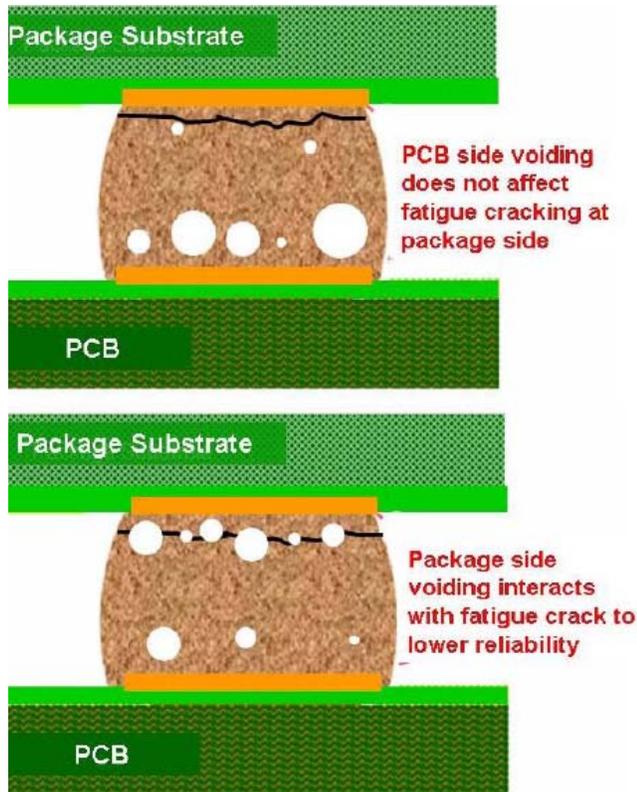
Figure 6. Impact of Voids on Solder Joint Integrity, D. Coyle et al [9]

The Coyle investigation found that macro voids reduce solder joint reliability by reducing the effective attachment area and that this geometric effect was independent of solder alloy composition. The study concluded that the dominant factor that impacts solder joint integrity was void location and not the void size or density of voids.

- Planar (flat) metallographic cross-sectioning thru package/solder joint interface showed a high incidence of voiding not observed in orthogonal cross-section
- Solder voiding had a negative impact on solder joint reliability only when void density was high and void location was in the crack path (Figure 6)

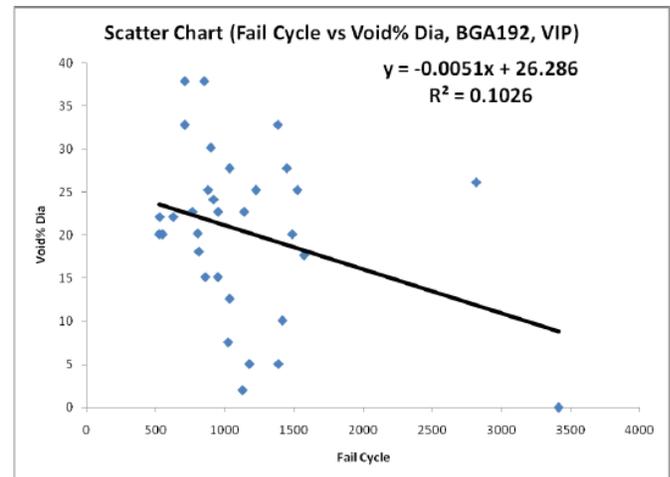
Figure 7. Scatter Chart Showing No Correlation between Solder Joint Void and Thermal Cycle Integrity, J. Smetana et al [10]

The Smetana investigation documented that for both a ceramic BGA component and a plastic CSP component, the void diameter or area percentage had no correlation to solder joint thermal cycle integrity. Cross-sectional analysis revealed numerous examples of thermal cycle fatigue cracking having no interaction with the solder joint void.

- A total of 21 of 40 test vehicles had a void greater than 45% of solder ball diameter or 20% of ball area
- Solder crack path typically found at solder joint / BGA package interface
- Via in Pad (VIP) resulted in significantly more voids in BGA/CSP solder joints than no Via in Pad design
- The voiding percentage in area or diameter of the BGA solder joints did not correlate to the failure cycle in thermal cycling (Figure 7)

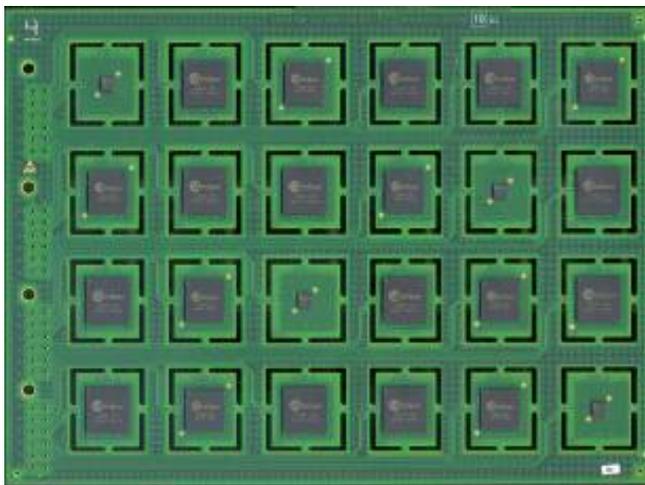
Figure 8. As-Assembled Test Vehicle

The test board was 2.18mm (86 mil) thick with 14 dummy inner layers. The board was constructed using FR-4 material in accordance with IPC-4101/126 with an electroless nickel/immersion gold (ENIG) surface finish. Figure 8 illustrates a completely assembled test vehicle without the ribbon cable used for monitoring current continuity. Microvias in accordance with IPC-6012 Class 3, Type 4 and IPC 2315 Type II were placed in the component pads to facilitate void generation in the solder joints. Table 3 lists the specific micro-via design data for each component on the test vehicle. Through-holes were arranged along one side of the test vehicle for ease of organizing cabling to the PWB. Instead of using a connector, ribbon cable leads were manually soldered to the through holes corresponding to each component I/O pair.

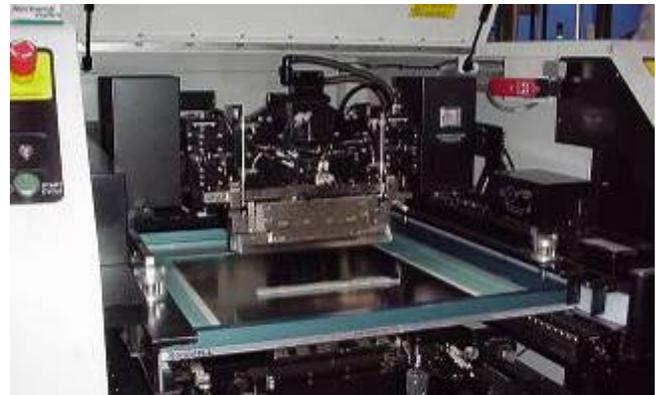
Figure 9. MPM Stencil Printer

The test vehicles were assembled at the Rockwell Collins Coralville production facility. An MPM Ultra Print 2000 automated stencil printer using a 0.005 inch thick stainless steel stencil applied solder paste to the test vehicles (Figure 9). The solder paste was Alpha tin/lead solder alloy WS-609. The components were placed using the Universal Advantis machine.

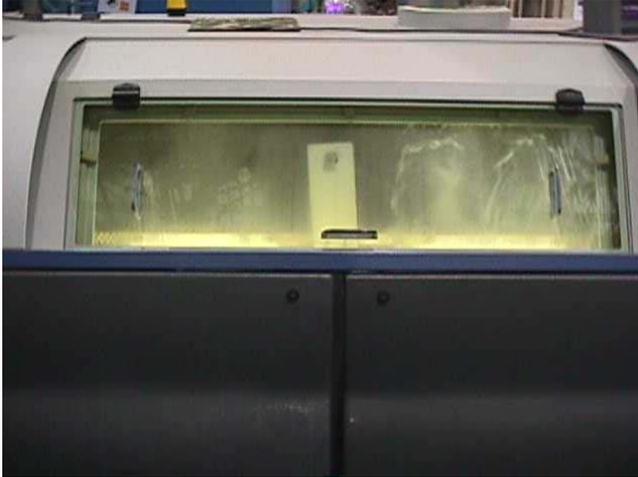
Figure 10. Electrovert Aquastorm In-line Cleaning System

The test vehicles were allowed to air cool after reflow and then placed in the Electrovert Aquastorm 200 in-line cleaning system for removal of solder flux residues and other contaminants from the assembly. The in-line cleaner utilized 13.5% (by volume) Kyzen Aquanox 4625 saponifier in deionized water. The in-line cleaner is shown in Figure 10.

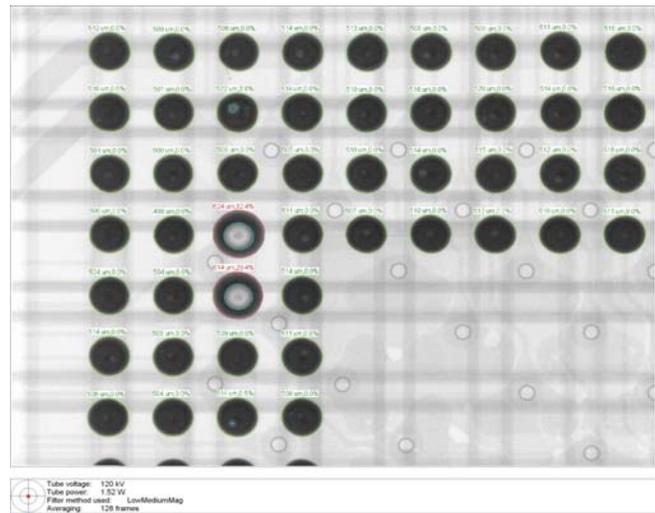
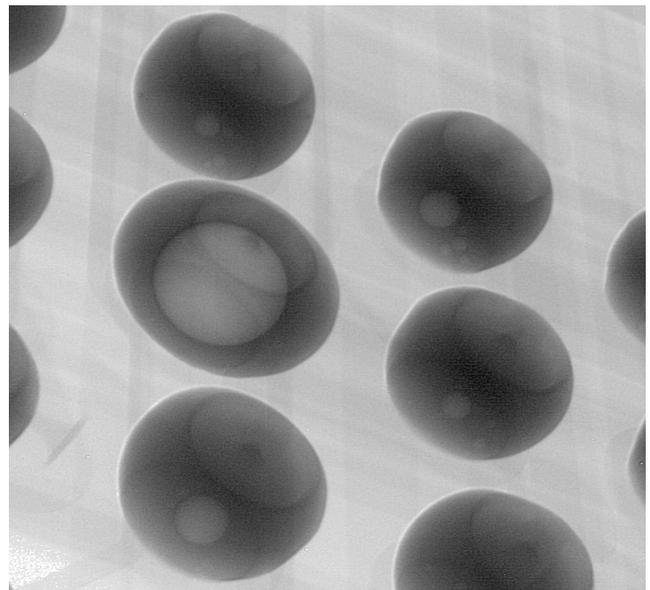
Figure 11. X-ray Examination of Test Vehicle Revealing: Top - Voids of 32% and 29% Area, Bottom - Oblique Angle X-ray View of 30% Void in BGA

The range of solder voids recorded was from 0% - 35% of X-ray image area, with the majority of the population in the 1% - 10% range. A larger population of solder voids in the 25%-35% range would have been desirable but sufficient solder voids greater than the IPC-JSTD-001 specification of 25% were observed to make the investigation valid. Figure 11 (top) illustrates voids of 32% and 29% area on the inner rows of a test component. Additionally, the low voiding % of the other solder joints is visible. Figure 11 (bottom) shows an oblique view X-ray image of a BGA ball with 30% void. It also shows the interfaces of the solder joint as ellipses above and below the ball.

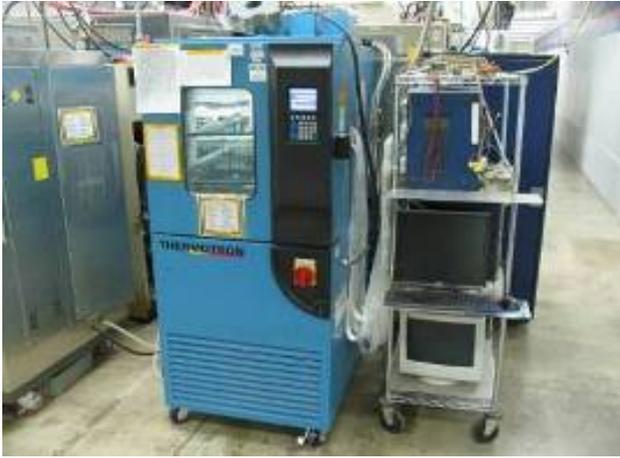
Figure 12. Thermal Cycling Chamber and Anatech

The temperature cycle range used in this study was -55°C to +125°C with a minimum 15 minute dwell at each temperature extreme and a maximum temperature ramp of 10°C/minute. Figure 12 shows the thermal cycling chamber along with the Anatech Event Detection system.

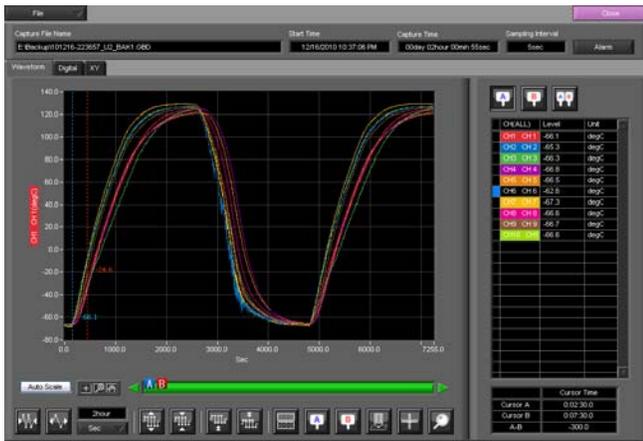
Figure 13. Thermal Profile

Figure 13 illustrates the thermal profile recorded using the Graphtec Midi Logger GL220 temperature acquisition unit.

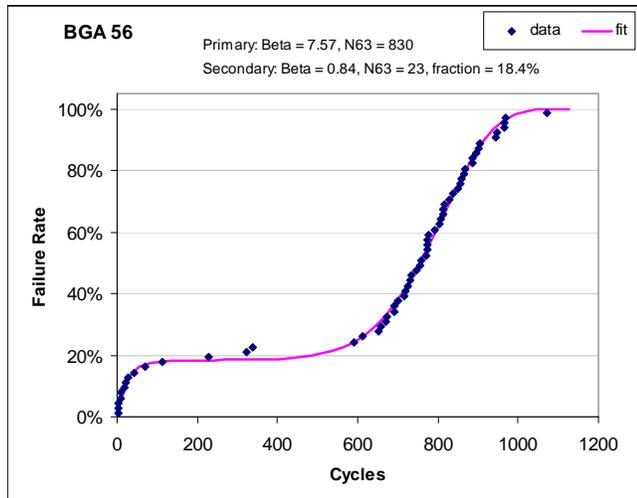
Figure 14. Mixed Mode Weibull Fit for BGA56 Data with Voids

The initial analysis of the data showed that the BGA56 data exhibited characteristics that would be typical of a failure population that contained two distinct failure modes. Figure 14 shows this behavior, in which a number of samples failed prior to 200 cycles, followed by the majority of the population surviving past 600 cycles. A mixed mode Weibull fit was calculated using the equation below. This

adds two separate Weibull functions, with one multiplied by p (the portion of the total population that fails due to the first failure mode) with the other multiplied by 1-p, i.e. the portion of the population that fails by the second failure mode. An iterative approach was used to calculate the Weibull coefficients and values of p that gave the best fit to the equation.

Figure 14 showed that the Weibull analysis indicated the existence of two failure modes impacting the BGA56 component solder joint integrity results. Cross-sectional analysis was conducted on the U1 BGA56 component based on the analysis illustrated in Figure 16. The cross-sectional analysis revealed that insufficient solder paste transfer occurred at the U1 component location. The lack of solder paste resulted in the U1 component making an electrical connection with no solder joint structural integrity. The U1 component condition is not a valid solder joint configuration, which justifies its removal from the investigation data set for assignable cause. Figure 29 and Figure 30 illustrate the defective U1 component pad location. The solder joint has a pad impression where it made electrical contact before the thermal cycle induced stresses caused failure.

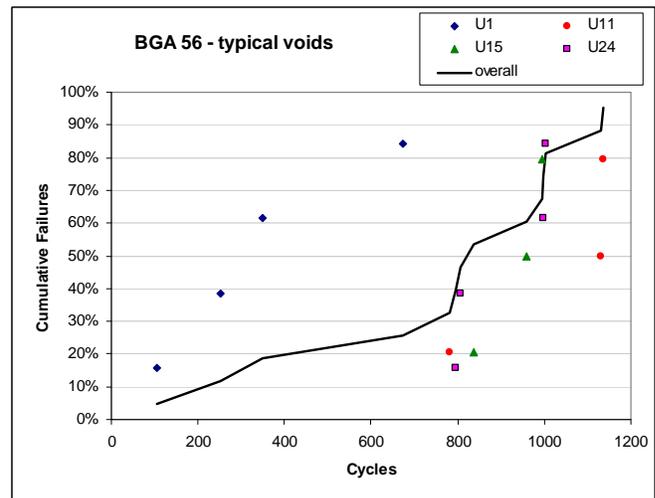
Figure 15: Failure Distributions for BGA56, by Reference Designator, With Typical Voids

The data for the assembly with typical voids (i.e. a void range of 1-10% of X-ray image area) similarly exhibited mixed-mode reliability characteristics. Upon further investigation, it was determined that in both data sets virtually all of the early failures occurred in the same component location on the test board (reference designator U1).

Figure 15 and Figure 16 clearly shows the significant difference in the reliability of the U1 components, which were located in one corner of the test board, compared to the other BGA56 components. This indicated that the secondary failure mechanism was due to an assembly process root cause and not related to the absence or presence of voids in the solder joints. Therefore, subsequent data analysis did not include the data for component reference designator U1.

For reference, the symbols and colors used in Figure 15 through Figure 18 were defined to help to identify any trends related to the location of a reference designator on the board. Symbols indicate which of the four horizontal rows on the test board that a particular reference designator occupied while the colors correspond to a column. The color/symbol combinations for the reference designator locations are shown Figure 19. There does not appear to be any distinct correlation between the reliability of the components and their location on the test board.

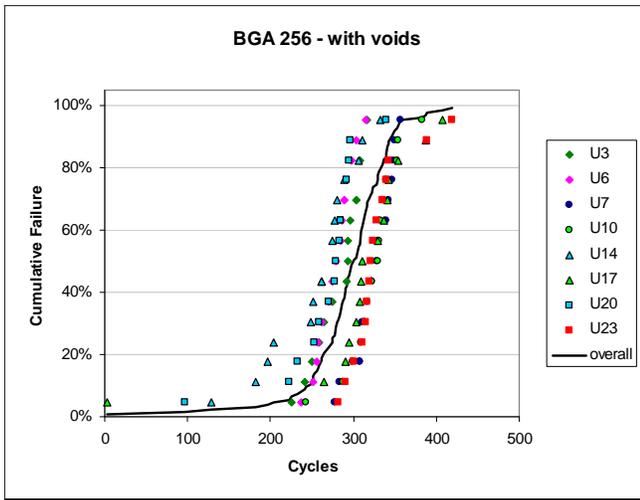
Figure 17. Failure Distributions by Reference Designator

A similar reference designator level analysis was conducted for the BGA256 and BGA288 devices. The results of this analysis, for the samples with voids, are shown in Figure 17 and Figure 18. While these results do show that there was some variation among the individual reliability characteristics depending on the particular reference designator, other than U1 in the BGA56 data set, these differences do not appear to be statistically significant.

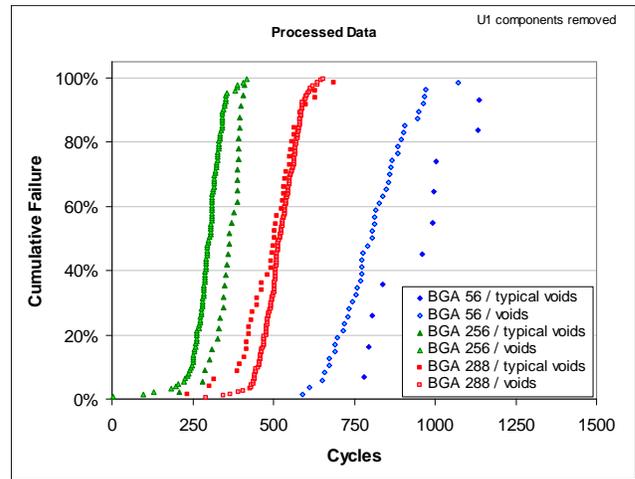
Figure 20. Component Reliability Results

The overall reliability data for the study, not including the data for U1, is shown in Figure 20. This clearly shows that the additional voids have relatively little impact to the

overall reliability of the components. The Weibull coefficients calculated for all three components and for typical and voided conditions are shown in Table 4. This table also indicates the impact of the voids on the characteristic life calculated for each data set.

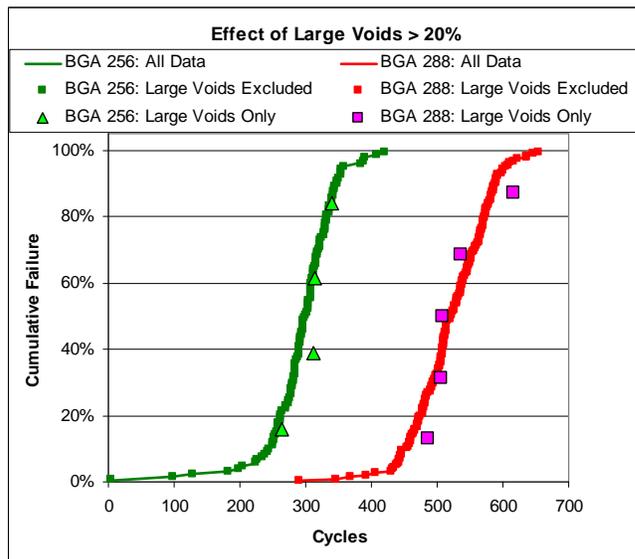
Figure 21. Effect of Large Voids Reliability Results

Figure 21 compares the reliability curves for all samples of BGA 256 and BGA 288 components with voids greater than 20% to the rest of the samples tested. The similarity between the trend lines, and the calculated Weibull coefficients shown in Table 5, indicate that the samples with and without voids had the same reliability.

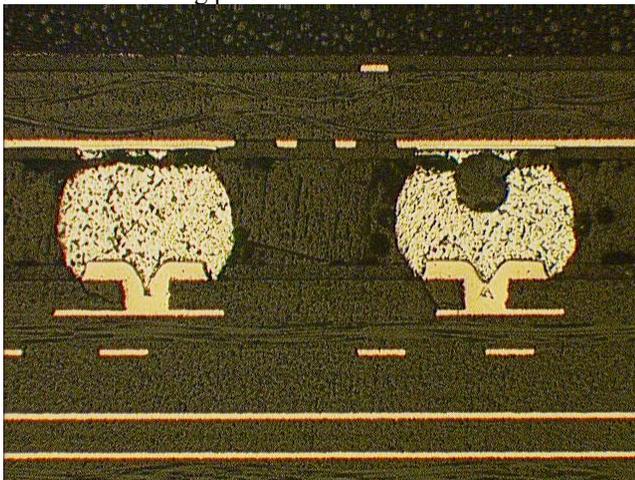
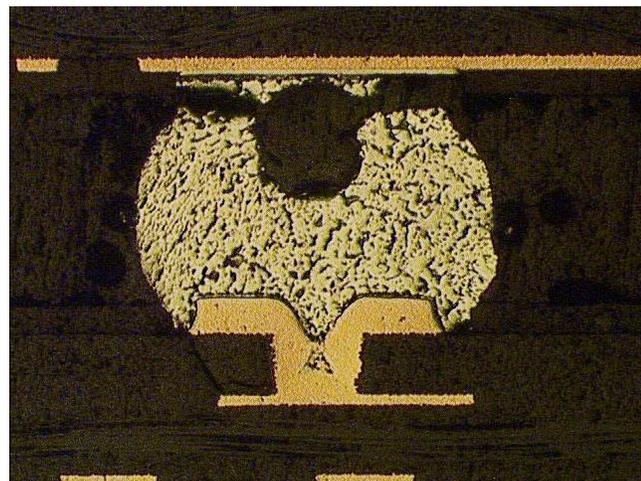
Figure 22. Macro (Top) and Magnified (Bottom) Views, BGA Void Assessment: 18% Void, Outer Row, 264 Cycles, BGA256

Figure 22 (top image) illustrates two BGA corner/outer row solder joints that failed in the typical location at the component/solder joint interface. One of these solder joints (magnified lower image) has a void less than the 25% maximum requirement but did undergo a loss of solder joint integrity. Figure 23 (top image) illustrates two BGA corner/outer row solder joints that failed in the typical mode but with no voiding present.

joints with voids less than 25%, it was primarily due to the location of voids in the crack path. This reduced the overall crack path length necessary for joint failure. Figure 22 and Figure 23 illustrate this observation with the void containing solder joint failing slightly earlier (i.e. within 50 cycles) than the non-void containing solder joint. Other examples found during the cross-sectional examination demonstrated that the simple existence of a void was not the controlling factor for the loss of solder joint integrity. The location of void relative to the solder joint failure crack path had a much larger impact than the presence of the void alone. This result is in agreement with both the Sethuraman [8] and Coyle [9] investigations. The results did indicate a more significant effect of large void size on the solder joint thermal cycle integrity than found in the Smetana [10], Sethuraman [8], SPVC [6] and Coyle [9] investigations. It is presumed that the more pronounced effects of large voids observed in this study were the result of the larger temperature excursion (-55°C to +125°C) used for cycling. This wider temperature range imposed larger stress/strain forces on the test components than the forces imposed by the small temperature ranges used in the other investigations and exacerbated the stress concentrations.

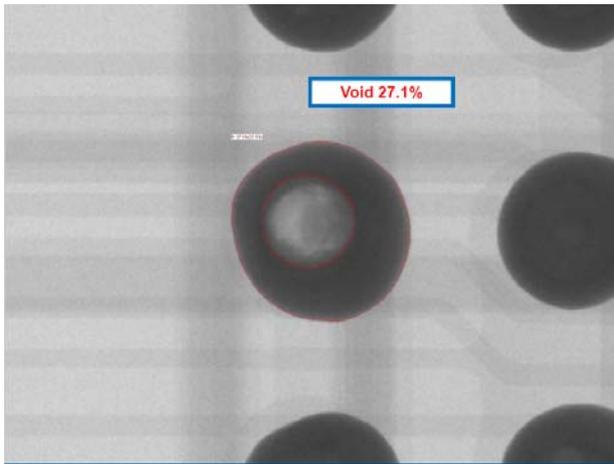
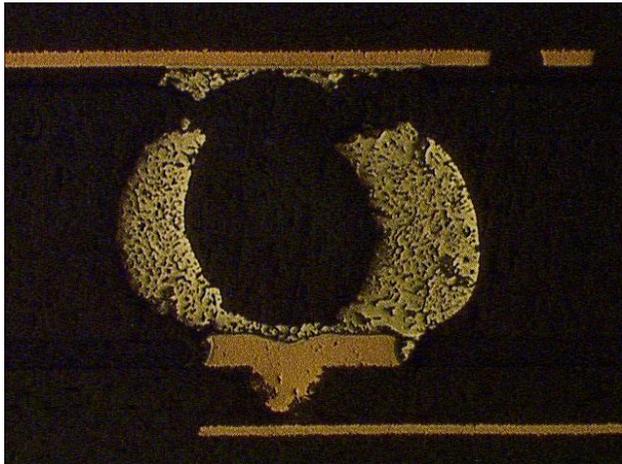
Figure 24. X-ray (Top) and Cross Sectional (Bottom) Views BGA Void Assessment: 27.1%, Outer Row, 505 Cycles, BGA 288

Figure 24 illustrates a solder joint failure due to a 27.1% void that reduced the crack path length and resulted in a loss of solder joint integrity. This BGA solder joint was located on the outer row but not a corner location. Figure 25 and Figure 26 illustrate a solder joint failure due to a 31.3% void reducing the crack path length. This BGA solder joint was located on an inner row/ near package corner location.

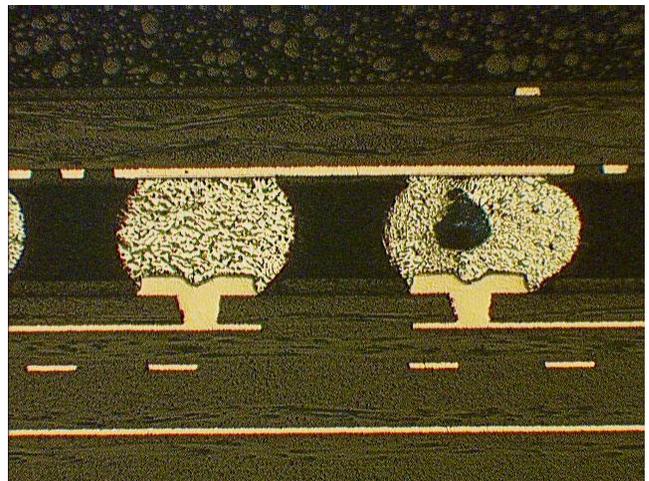
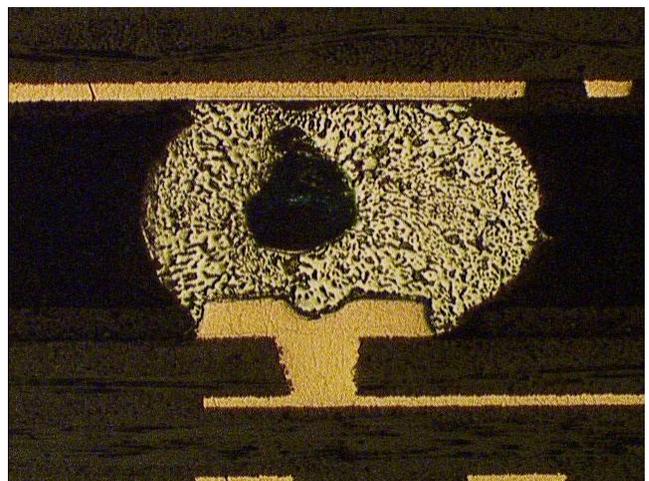
Figure 27. Macro (Top) and Magnified (Bottom) Views, BGA Void Assessment: 12%, Outer Row, No fail, BGA288

Figure 27 illustrates a typical solder joint containing a 12% void in a BGA solder joint that did not fail the thermal cycling test. This BGA solder joint was located on the outer row but not a corner location. Figure 28 illustrates a typical solder joint containing a 17% void in a BGA inner row that did not fail.

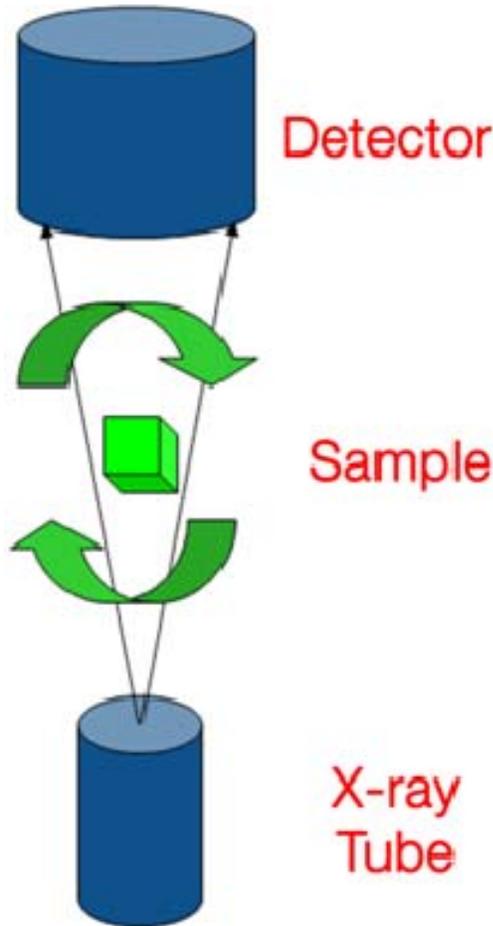
Figure 31. Schematic representation of the image acquisition phase of CT inspection

There are three stages to producing and using a CT model. These are:

taken, the more information there is for the CT reconstruction.

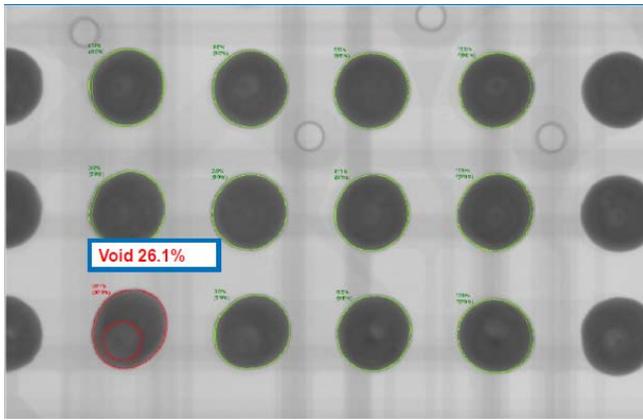
Figure 32. 26.1% BGA Voids Selected for CT Assessment

Figure 32 is a 2D X-ray image of the area of interest incorporating void calculations. The location of the voids within the joint is much better assessed using 3D CT virtual cross sectioning. Figure 33 (top) provides a 3D overview of the examined area and Figure 33 (bottom) represents a virtual cross section through the particular BGA row. Black areas represent voids/cracks. The location, size and shape of the voids can be precisely examined. The cracks resulting from the thermal cycling are also clearly visible. Once the CT model is compiled the failure analysis engineer uses dedicated software viewer to pan through each ball in slices as a continuous 'virtual cross-section' through the whole sample in order to evaluate the void size and location. The advantages here compared to mechanical cross-sectioning is that there are no limitations in the position of the virtual section plane, virtual sectioning is fully reversible (as it is done on a software model), and no additional mechanical defects are introduced.

Dr. Evstatin Krastev conducted 3D CT assessment of the BGA voids using the Nordson Dage XD7600NT100 X-ray inspection system after the completion of the thermal cycle testing. The CT assessment allowed for a better understanding of the void location within the solder joints and the interaction of the failure crack path/void interface. The CT assessment results were in agreement with the cross-sectional analysis results indicating that the outer row of the BGA/CSP was most influenced by the void size and location. Figure 32 and Figure 33 illustrate a typical example of the CT assessment of a 26.1% BGA Void on an outer row that failed at 616 thermal cycles.
